CA3115/80
AP-AW65

Thermally Broken, Historic, Projected Vent Window
PRESERVING AMERICA'S WINDOW HERITAGE

MODEL CA3115/80 SPECIFICATIONS

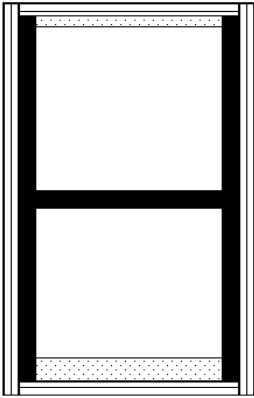
Thermally broken, Monumental, Historic, Projected vent window.

This thermally broken vent is designed to accurately replace steel sash with a modern insulated window .

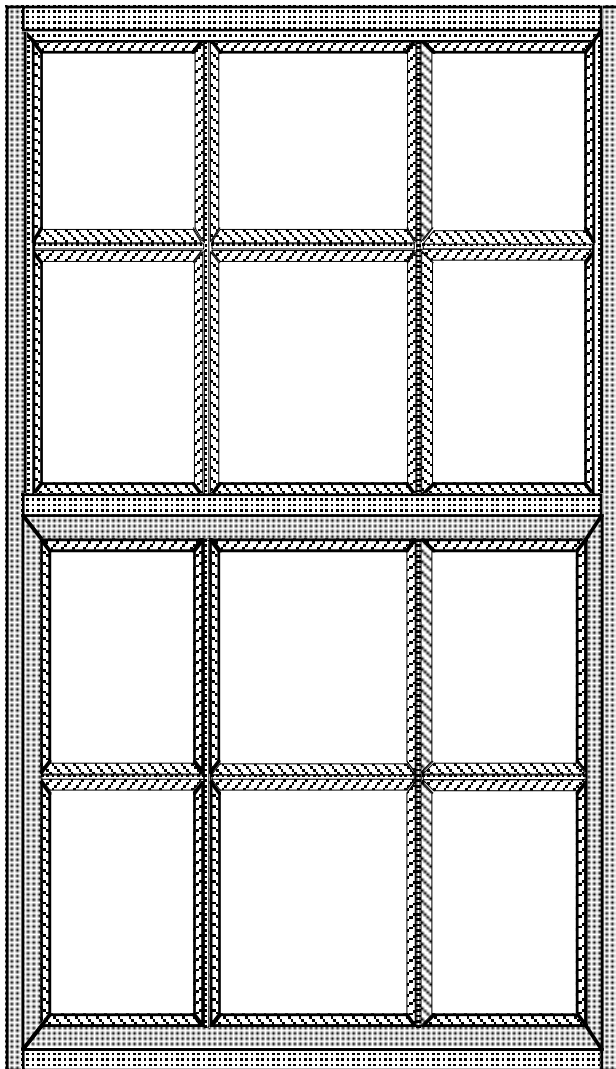
HEAD

MEETING
RAIL

Unique Applied interlocking Muntin system that provide the appearance of old steel muntins with a beveled perimeter to accurately replicate outside putty-glazed steel sash. Flush face construction, screen subframe that prevents exterior removal and obviates the need for wickets on many configurations.

Nominal wall thickness .125" 6063 T-5 extruded aluminum with integral poured-in-place thermal barrier. All vent members shall be of tubular construction. Vents shall present a flush profile with the mainframe. Vent joinery shall be mitre-cut with hydraulically crimped corner keys, frame joinery shall be butted and coped with stainless steel screws into integral screw ports.
